QA-305

Lands End Farm
Church Hill vicinity
Private

INVENTORY FORM FOR STATE HISTORIC SITES SURVEY

Lands End Farm

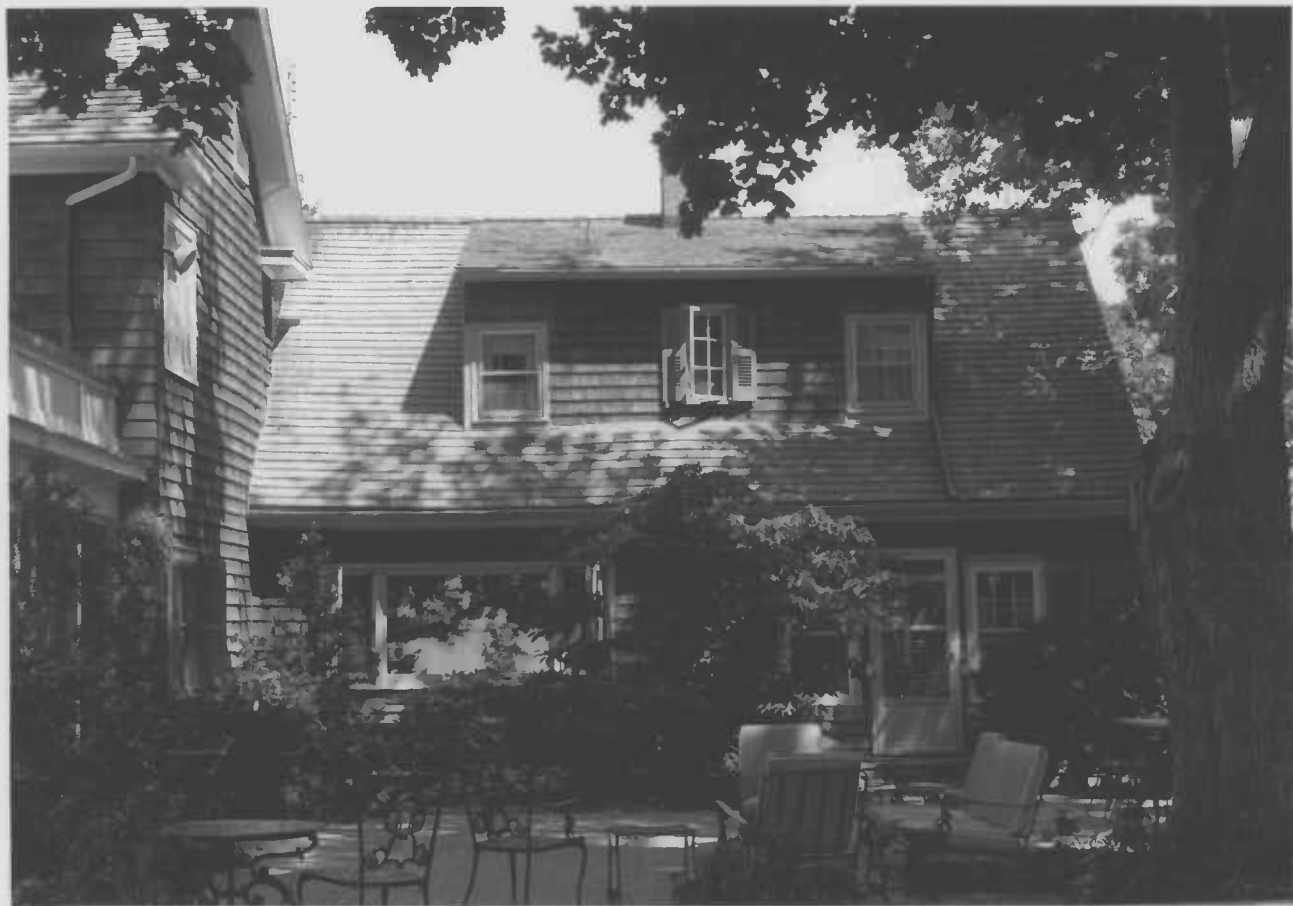
QA-305 Lands End Farm
Church Hill vicinity, Md.
Orlando Ridout V, 1978 (MHT)
Early wing, NW facade

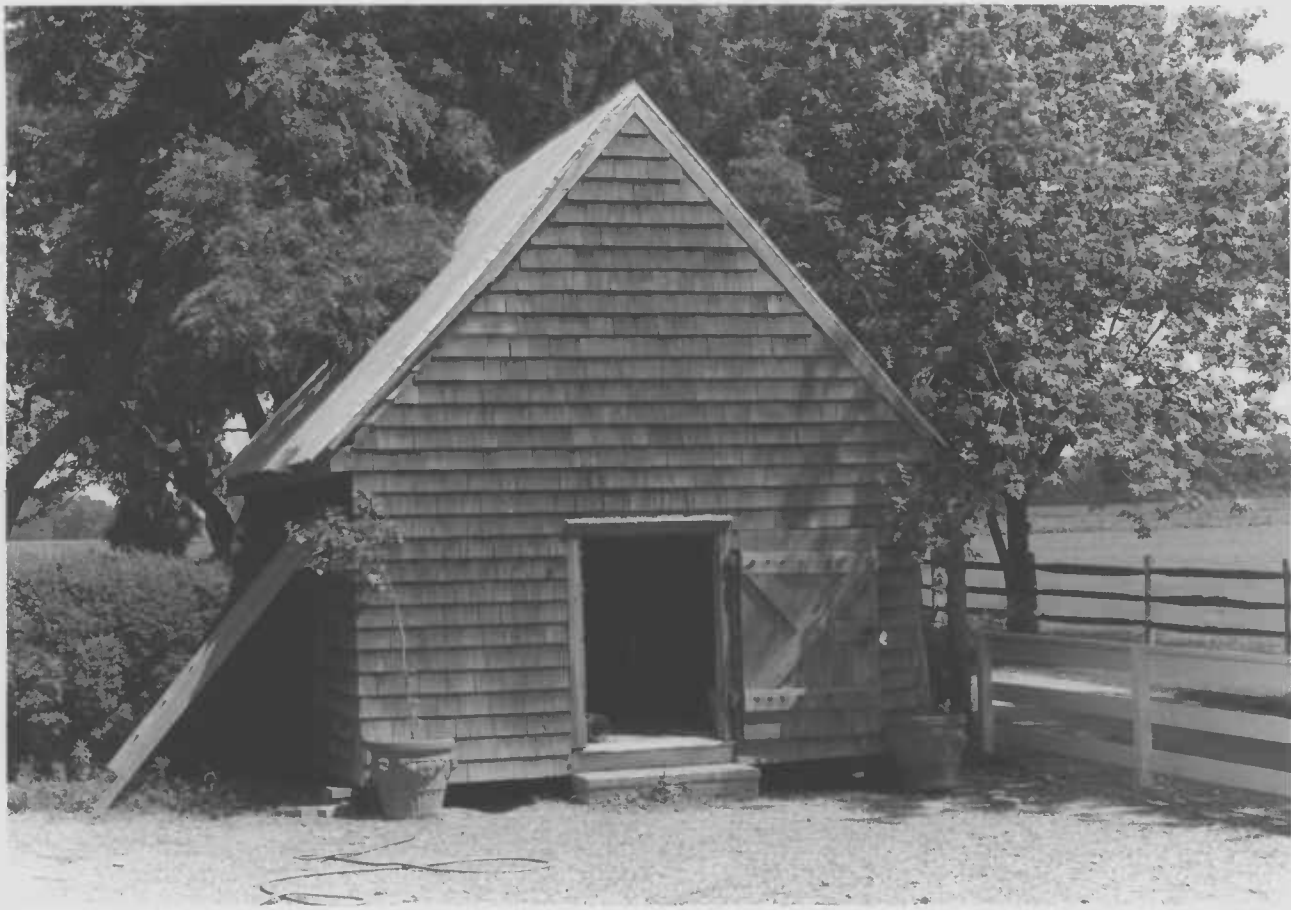
The meat house is approximately fourteen feet by sixteen feet, and rests on modern brick piers at the edge of the driveway. It is of post and plank construction, covered with wide vertical planks and wood shingles. The gable roof is approximately 45 degrees in pitch. There is one door in the center of the northwest gable. This is very wide and low, only four feet, eleven inches high. The door is not original, but is hung on large wrought iron strap hinges and pintels.

QA-305 Lands End Farm: Meathouse
Church Hill vicinity, MD
Orlando Ridout V, 1978 (MHT)
NW Gable, camera facing SE
